INVESTIGATION OF TENSION-COMPRESSION  
FATIGUE BEHAVIOR OF A UNIDIRECTIONAL  
METAL MATRIX COMPOSITE AT ELEVATED  
TEMPERATURE

THESIS

Darren L. Kraabel, 2nd Lieutenant, USAF

**AIR FORCE INSTITUTE OF TECHNOLOGY**

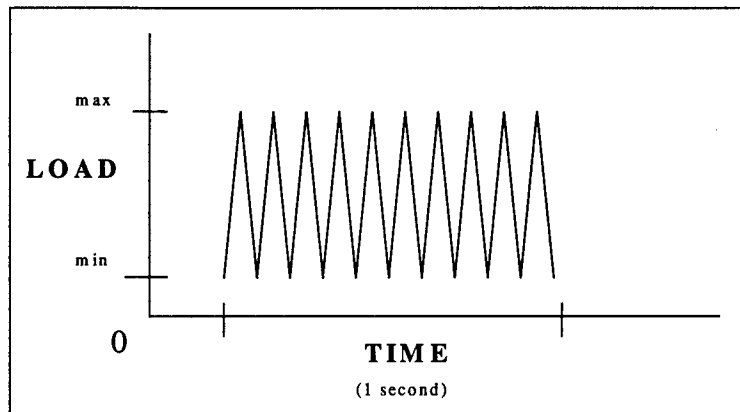
**Figure 1. Tension-Tension Load-Time Relationship,  $R=0.1$**

This research investigates the behavior of the [0]8, unidirectional laminate of SCS-6/Ti-15-3, MMC in tension-compression fatigue loading. High temperature (427 °C), fully reversed, load controlled fatigue tests (TC HT) were performed to obtain fatigue life data. Tension-tension fatigue tests (TT HT) at 427 °C were also performed to verify testing techniques and material properties. Tests were performed at a frequency of 10 Hz, with the exception of the high stress tests which were conducted at 1 Hz. The tension-compression tests had a load ratio (minimum load/maximum load) of  $R=-1$ , while  $R=0.1$  for the tension-tension tests. These load-time relationships are shown in Figures 1 and 2.

stress. The loading type varied between tension-compression and tension-tension (Figures 1 and 2), thereby also altering the mean stress. During tension-compression testing, the mean stress is 0 while it depends on a positive load ratio ( $R$ ) for the tension-tension loading condition. For the tension-tension tests in this study,  $R=0.1$ . While all of these factors do influence the fatigue life of the material in this study, frequency does not at this temperature. Discussion of the effects of frequency is found in Appendix A.

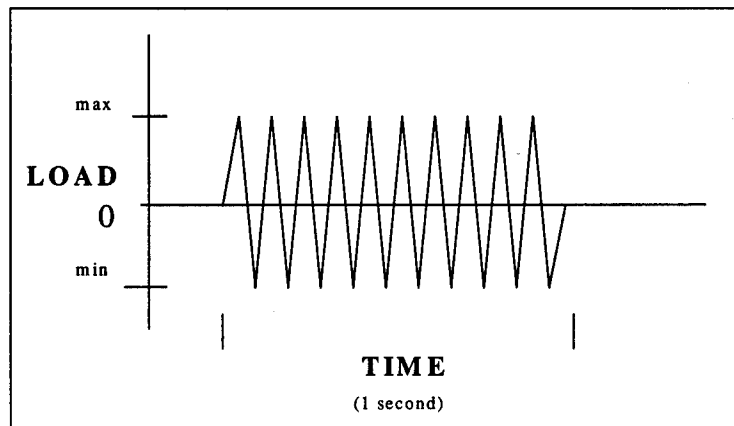
**Figure 2. Tension-Compression Load-Time Relationship,  $R=-1$**

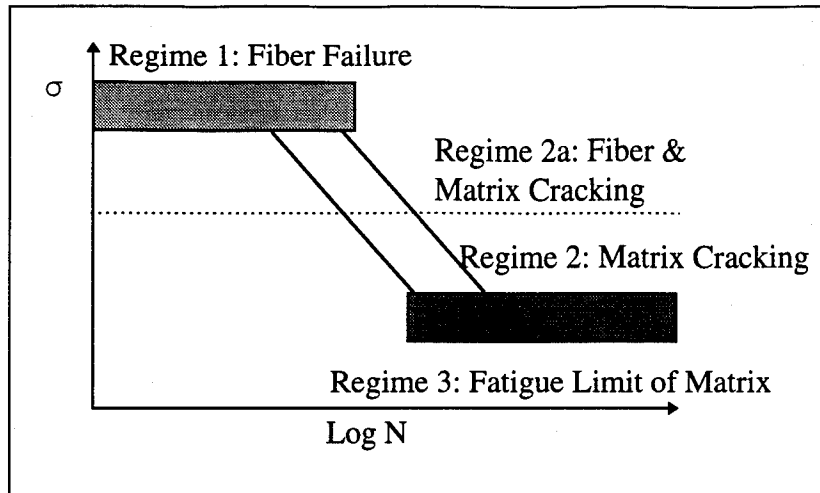
**Figure 3. Boyum's Model for Regimes of Cross-Ply Laminate S-N Curve**

For composite materials, fatigue life diagrams are often broken into regimes consisting of varying failure mechanisms. Following Taljera's approach (38), many researchers have broken the fatigue life of a MMC into three distinct regimes: Regime 1, 2 and 3. Specifically, Majumdar and Lerch have separated the S-N curve for the unidirectional SCS-6/Ti-15-3 laminate, tested in tension-tension at an R-ratio of 0.1, into Regime 1, which is dominated by fiber failure, Regime 2, which is dominated by matrix failure, and Regime 3, which consists of specimens that did not fail and fall below the fatigue limit of the material (21). Between these regimes, the authors found the failure modes to be complex, consisting of combinations of failure modes. Boyum, who tested a cross-ply laminate under tension-compression conditions, elaborated upon Taljera's approach by breaking Regime 2 into two separate qualitative regimes, Regime 2a and Regime 2 (4). In Regime 2a, the higher range of applied stress, failure was caused by a combination of fiber and matrix cracking while Regime 2 consisted solely of matrix cracking. Boyum's regimes are shown in Figure 3.

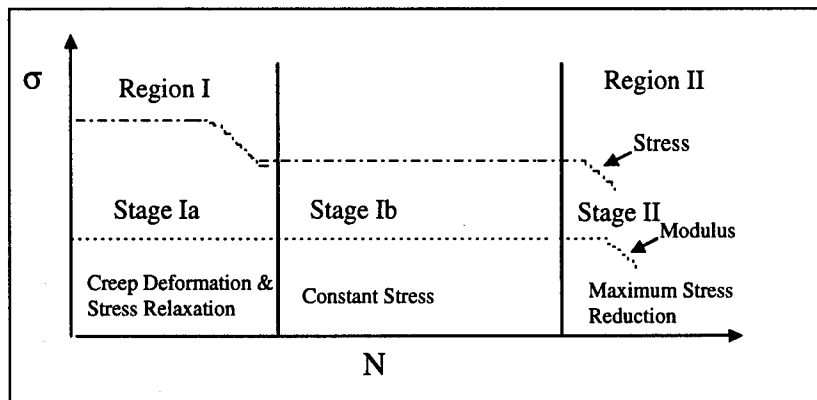
**Figure 4. Sanders' Model for Regimes of  $[0]_8$  Laminate**

The macroscopic response of a composite can also be separated into regions defining various behavior. Sanders analyzed fatigue life data for strain-controlled fatigue by breaking the  $\sigma$ - $\epsilon$  response over time into two stages (32). Stage I is dominated by matrix creep and can be broken into two sub-stages, Ia and Ib. Stage Ia consists of creep deformation of the matrix resulting in a relaxation of the lamina stress. Stage Ib represents the region where the maximum applied stress remains constant. Stage II is defined by a reduction in the maximum stress. These stages are schematically shown in Figure 4.

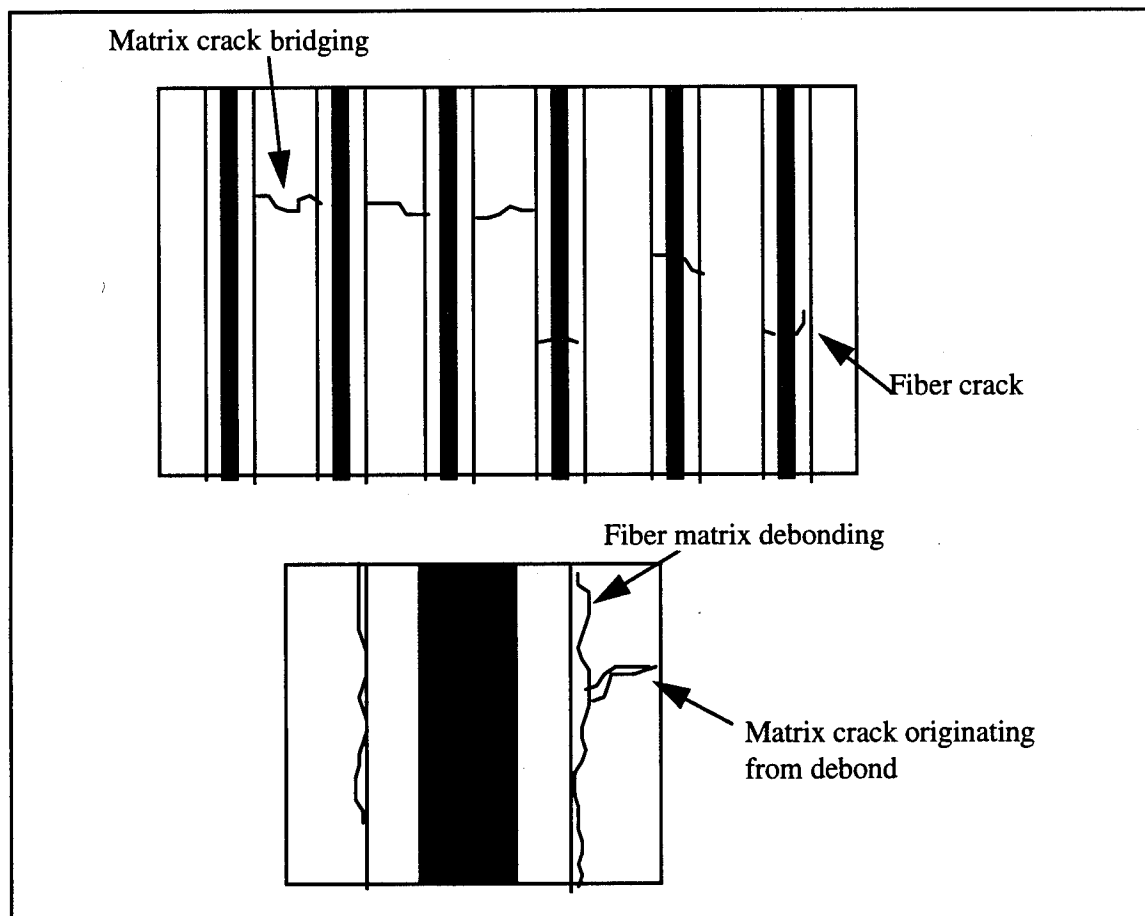
**Figure 5. Damage Mechanisms**

Micro-mechanical analysis in the current study is broken into two separate groups, damage and plasticity. Damage mechanisms include matrix cracks, fiber breaks, and fiber-matrix debonding. Plasticity includes slip band formation, crack nucleation and fatigue striations, which are similar to slip bands. The type of damage in each specimen is dependent upon the applied stress level. Figure 5 illustrates the damage mechanisms as they pertain to a unidirectional laminate.

Damage is defined by the creation of new free surfaces from fiber and matrix crack growth. Cracks may originate within the fiber and matrix itself or they may originate from fiber-matrix interfaces. Fiber cracks may cause debonding between the fiber and matrix. This debonding prevents the fibers from transferring any load to the

matrix. Debonding may also occur from low interface strength caused by poor material processing. Debonding of this nature provides numerous crack initiation sites within the matrix. The two types of debonding are important in determining what causes failure. Extreme necking around fibers shows a great deal of debonding which is caused by fiber overload, i.e. fiber cracks. Debonding that shows less necking indicates destruction of the fiber-matrix interface due to low interface strength. Matrix cracks are likely to originate from this region whereas fiber cracks may be nonexistent.

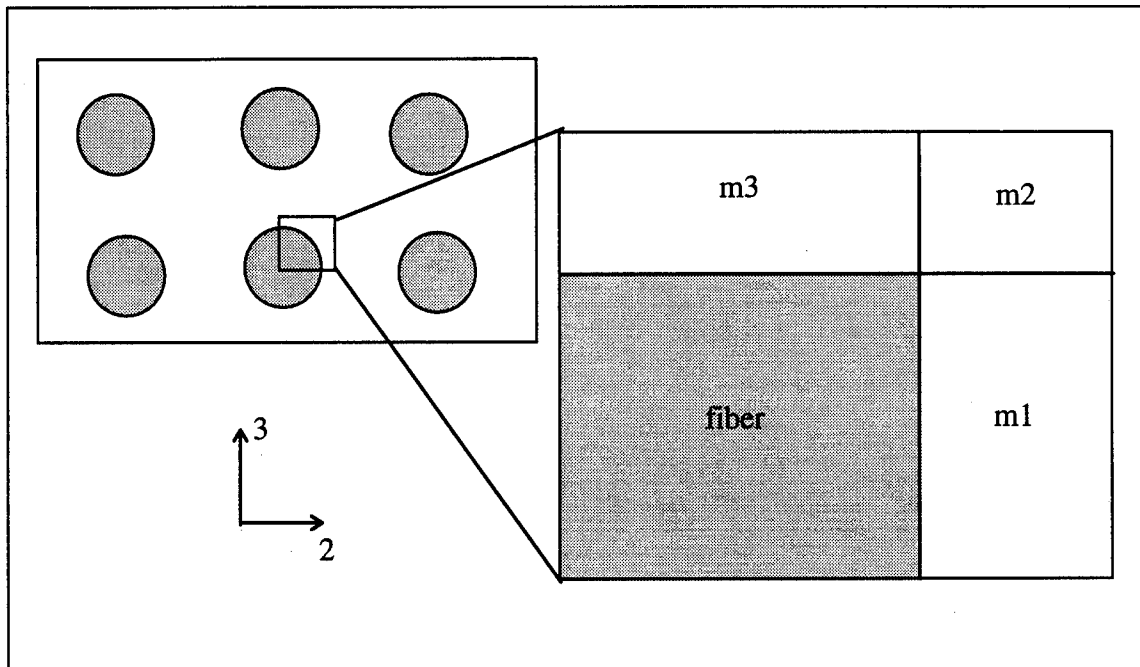
**Figure 6. Representative Unit Cell**

tenet that classical laminated plate (CLP) theory assumptions on the strain variation apply to the non-linear laminate formulation. It also incorporates a unified viscoplastic theory for the inelastic matrix behavior. This theory is based on combining plastic and viscoplastic strain into a single term. The advantages of this model over others is that it more closely models laminates containing off-axis plies. All calculations are made using the unit cell as illustrated in Figure 6. This cell models one quarter of the fiber and surrounding matrix, employing symmetry and equivalent boundary conditions.

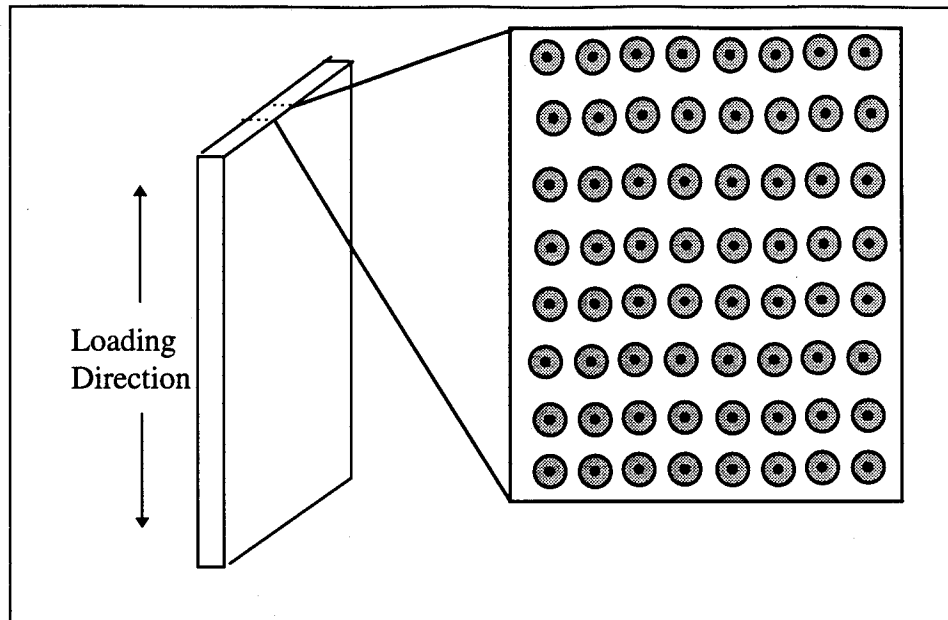
**Figure 7. Unidirectional Metal Matrix Composite [0]<sub>8</sub>**

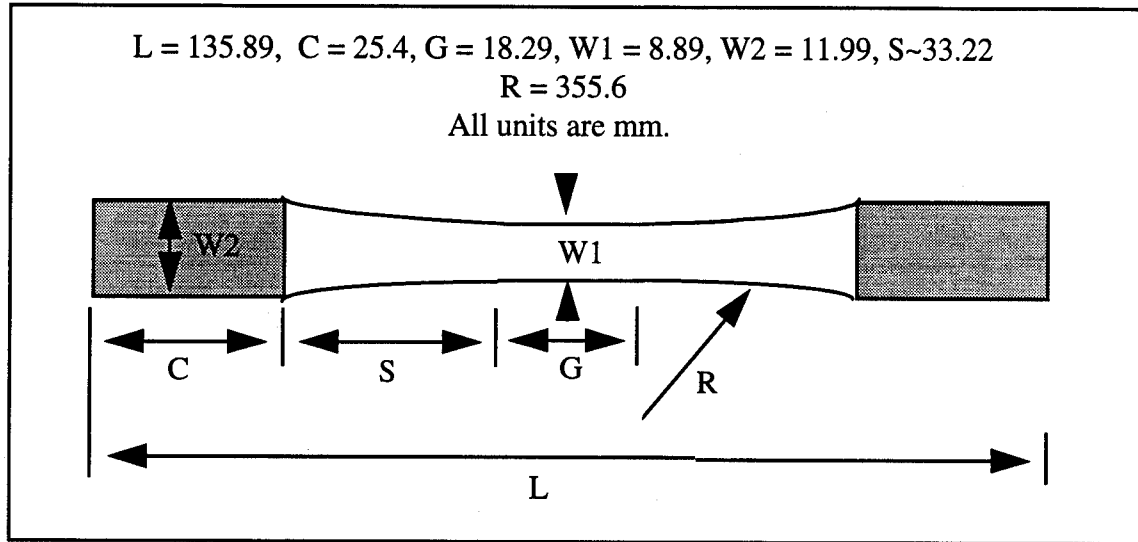
**Figure 8. Dogbone Specimen Geometry**

than 31.75 cm would produce a small enough shear stress. A conservative radius of 35.56 cm was used to further reduce the shear stress in the shoulder region. Consistent failures within the gage length indicate that the specimen design works well for fatigue testing. Thus, the specimen design used for this study is identical to the one used by Majumdar and Newaz. The specimen geometry is shown in Figure 8.

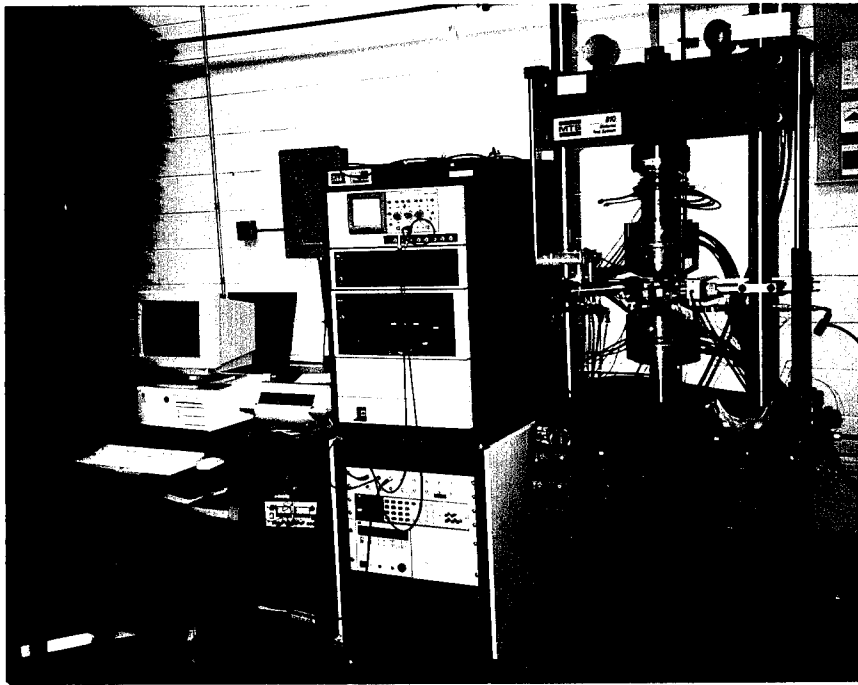
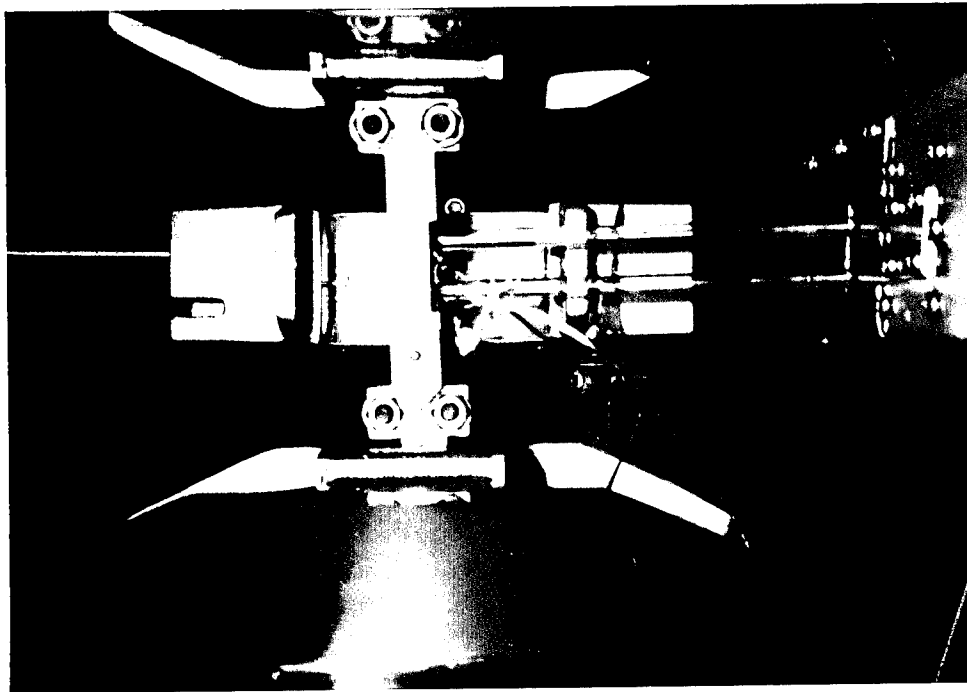
**Figure 9. Test Setup**

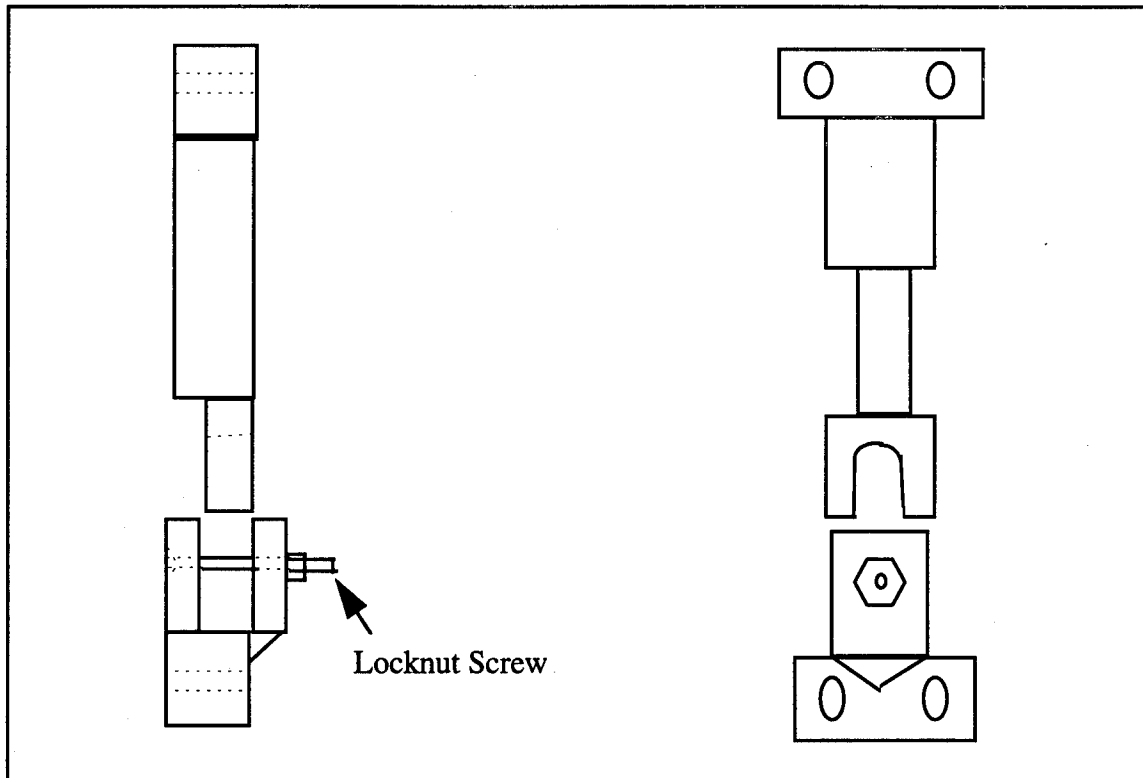
**Figure 10. Buckling Guide Modifications**

The guide, as designed by Boyum, would not fit the dogbone specimen used for this study. Also, initial testing indicated that the diameter of the locknut screws was too small to withstand the large forces generated by buckling of the specimen during high stress tests. Thus, the overall length of the guide was shortened and the smaller half modified to withstand the increased loads. The modifications consisted of providing additional support to the locknut screw as shown in Figure 10.

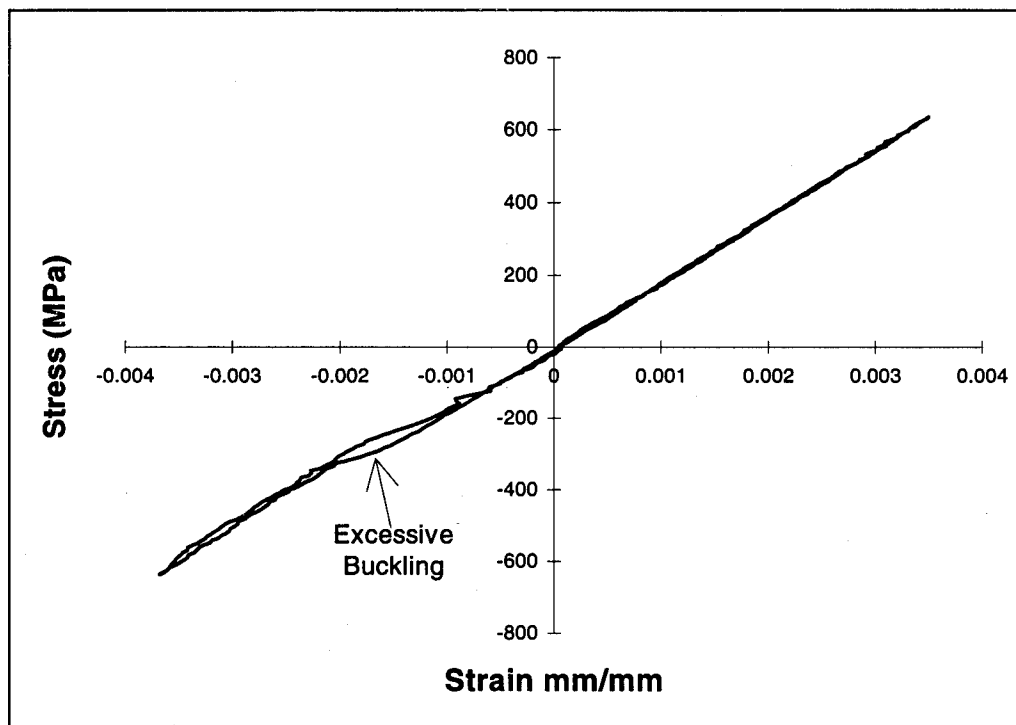
**Figure 11. Excessive Buckling**

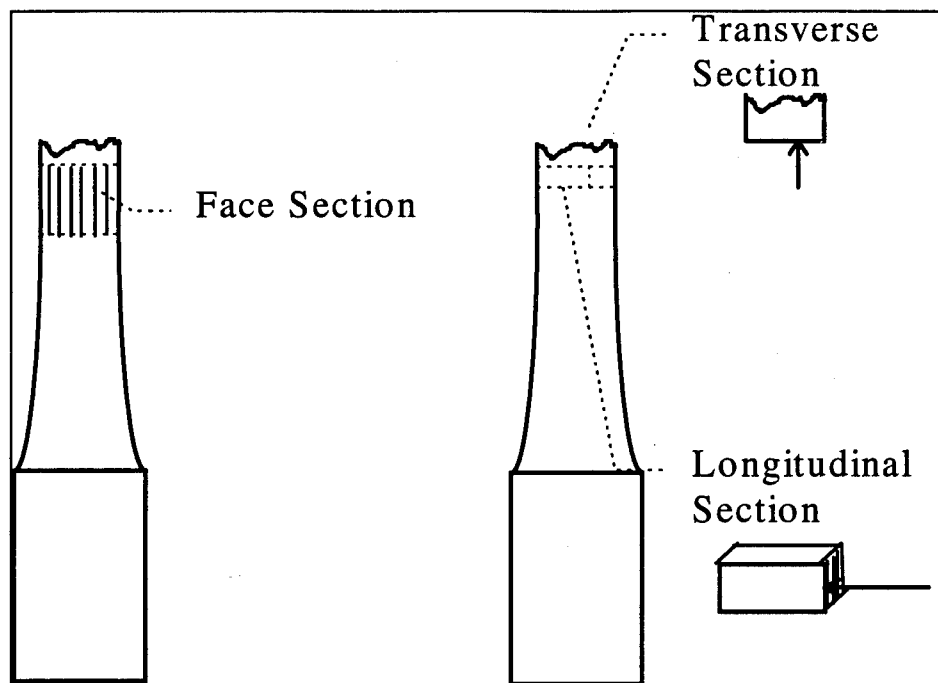
**Figure 12. Specimen Sectioning**

1  $\mu\text{m}$  solution Vibromet and polished for approximately 24 hours. The specimens are then moved to a 1/2  $\mu\text{m}$  solution Virbomet for approximately 8 hours. Lastly, the specimens are placed in a mastermet solution Vibromet for 20 minutes.

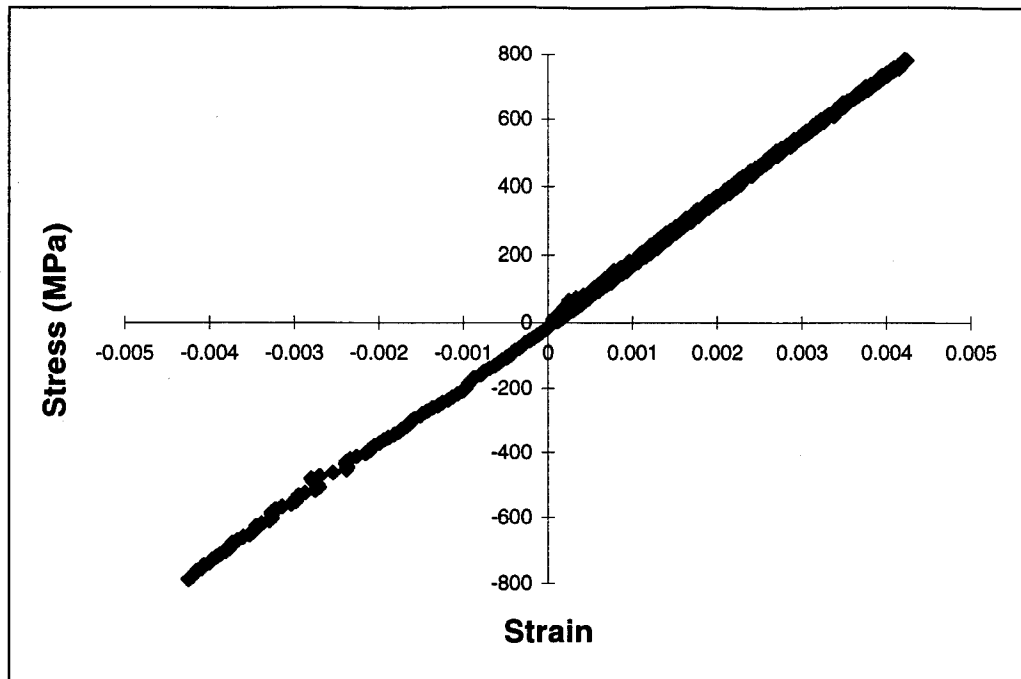
**Figure 13. Initial stress-strain curve, 800 MPa**

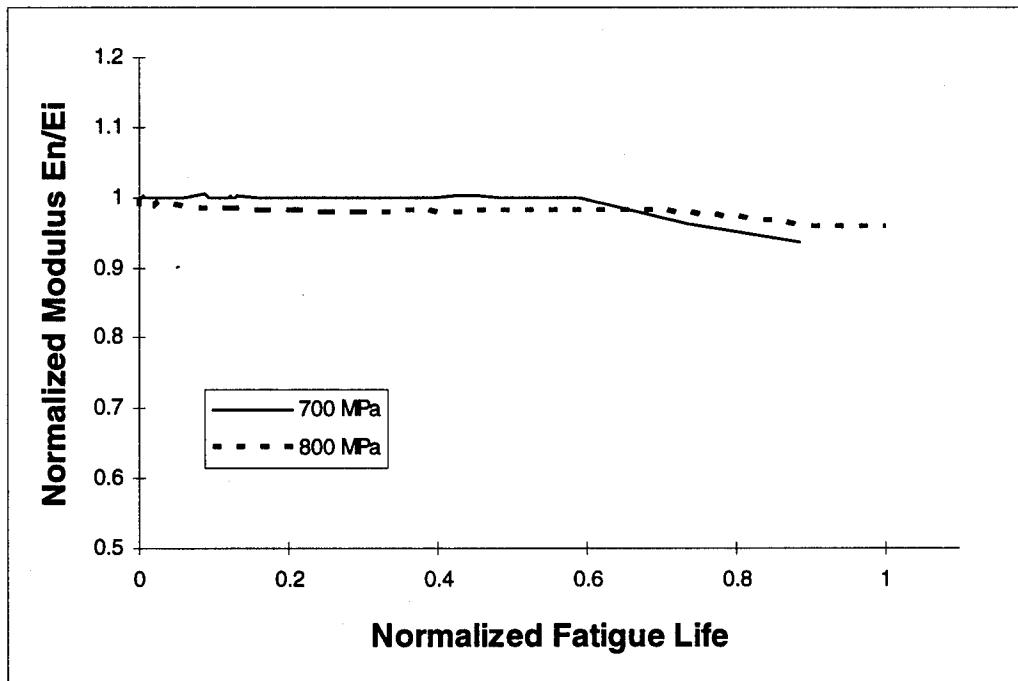
Figure 14. Group 1 Normalized Modulus Trends

Trends in the modulus during cycling are extremely helpful in determining the initiation of damage and the rate of damage progression throughout the fatigue life of the specimen. Generally, any degradation in the modulus indicates damage. Figure 14 shows the trends in the normalized modulus for all tests in Group 1. The normalized modulus is calculated by dividing the current modulus by the initial modulus. Likewise, the normalized fatigue life is calculated by dividing the current cycle by the number of cycles at failure.

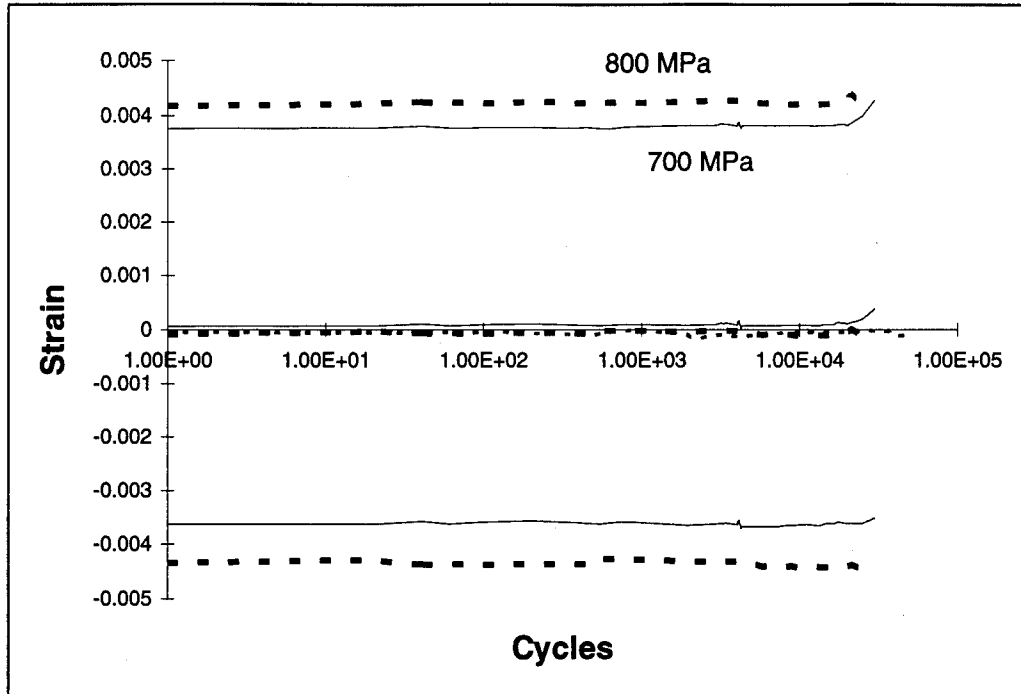
**Figure 15. Group 1 Strain Trends**

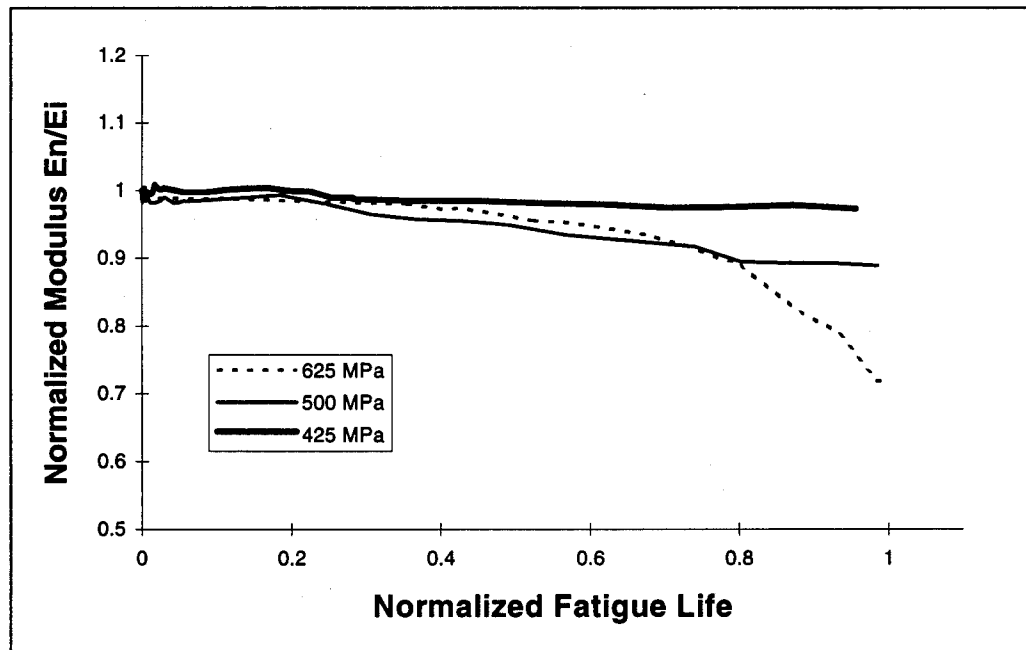
**Figure 16. Group 2 Normalized Modulus Trends**

Figure 16 shows the modulus trends for those specimens in Group 2. Upon initial inspection, the 425 MPa specimen shows a trend similar to that seen in Group 1, but microscopic evaluation and further macroscopic analysis show that this specimen exhibits behavior consistent with other specimens in Group 2. Whereas the modulus remained constant for approximately 60% of the fatigue life in Group 1, modulus degradation began after as little as 20-40% of the fatigue life in Group 2. Percentage of fatigue life should not be confused with actual cycle number. Simple calculations show that the modulus degradation in Group 2 began at later cycle counts than in Group 1, even though the corresponding fatigue life percentage is less for Group 2. Although modulus degradation at 425 MPa is not obvious in Figure 16, a plot of the actual modulus versus cycle count in Figure 17 shows a more dramatic reduction.

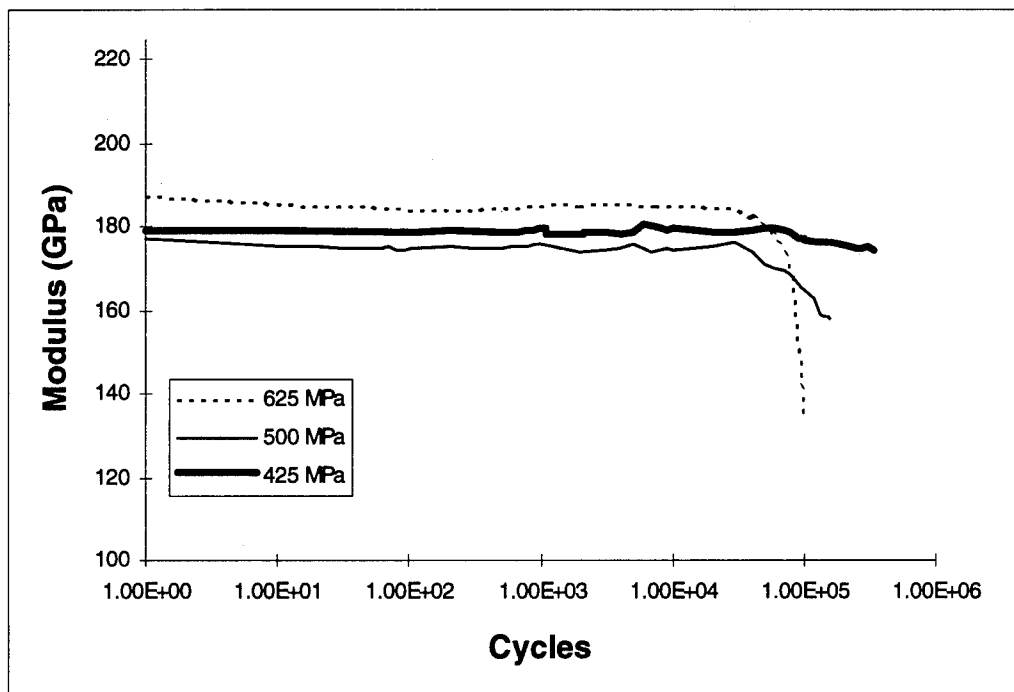
**Figure 17. Group 2 Modulus Trends**

The amount of modulus degradation in Group 2 also varies with the applied stress, as shown in Figure 17. As the applied stress increases, the amount of modulus degradation increases. This indicates that more matrix cracking occurs at higher stresses. Microscopy will show that the crack density increased with the increasing stress in Group 2.

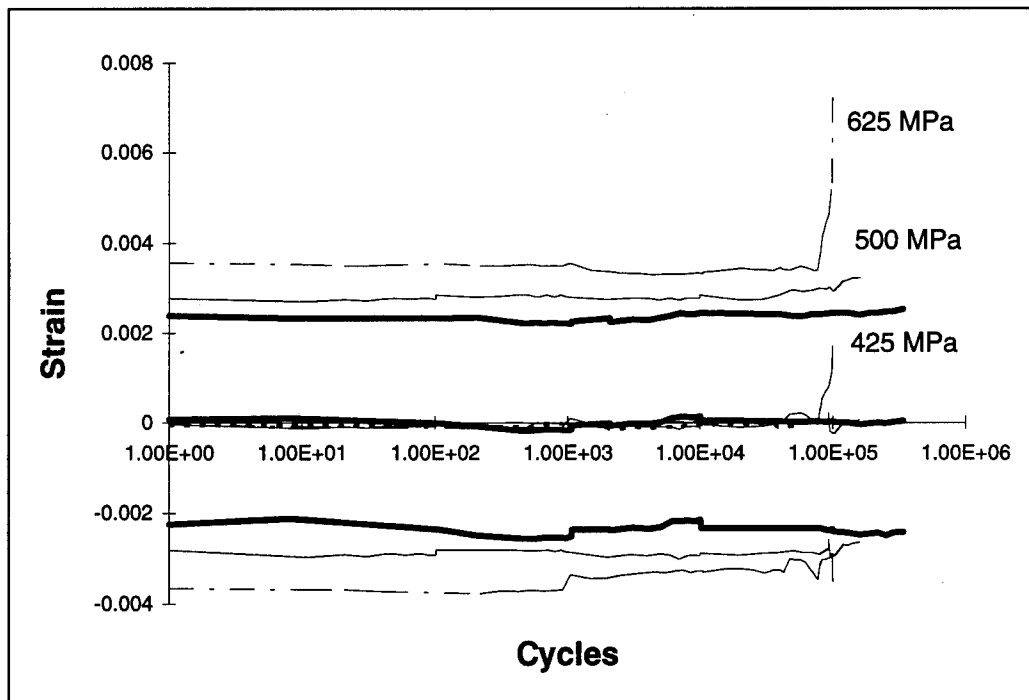
**Figure 18. Group 2 Strain Trends**

reduction was observed in the specimen cycled at 425 MPa, thereby explaining the lack of increase in maximum strain near the end of the fatigue life. Also, the decrease in modulus causes an increase in the strain range. This relationship can be shown by comparing the change in modulus versus the change in strain range as shown in Figure 19 where modulus and strain range data for the 625 MPa fatigue test are plotted against the fatigue life. The increase in strain range is caused by an increase in the tensile strain while compressive strain remains constant. To better illustrate the rise in strain range caused by an increase in the tensile strain, it is helpful to look at the stress-strain response.

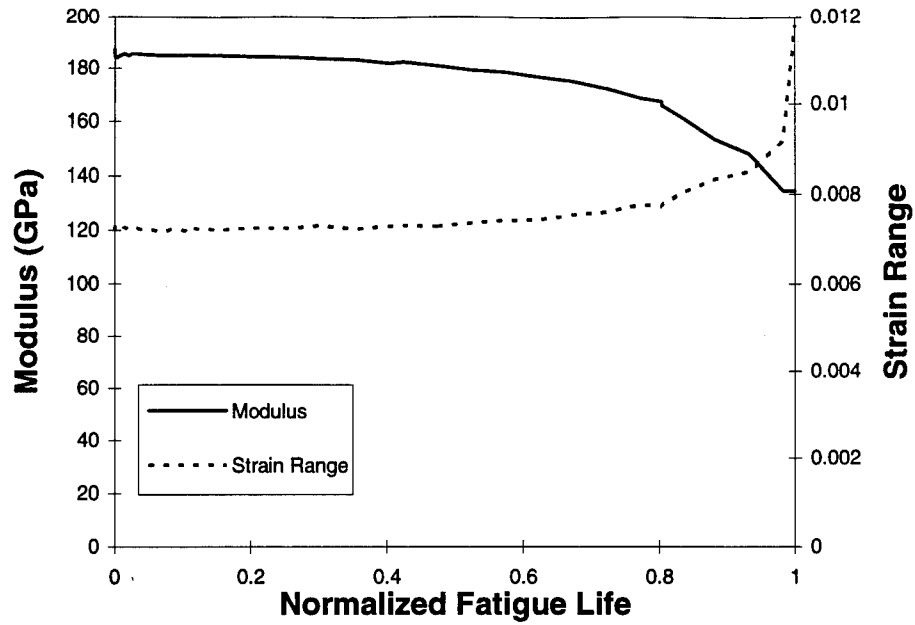
Figure 19. Modulus, Strain Range Data for 625 MPa, T=427 ° C

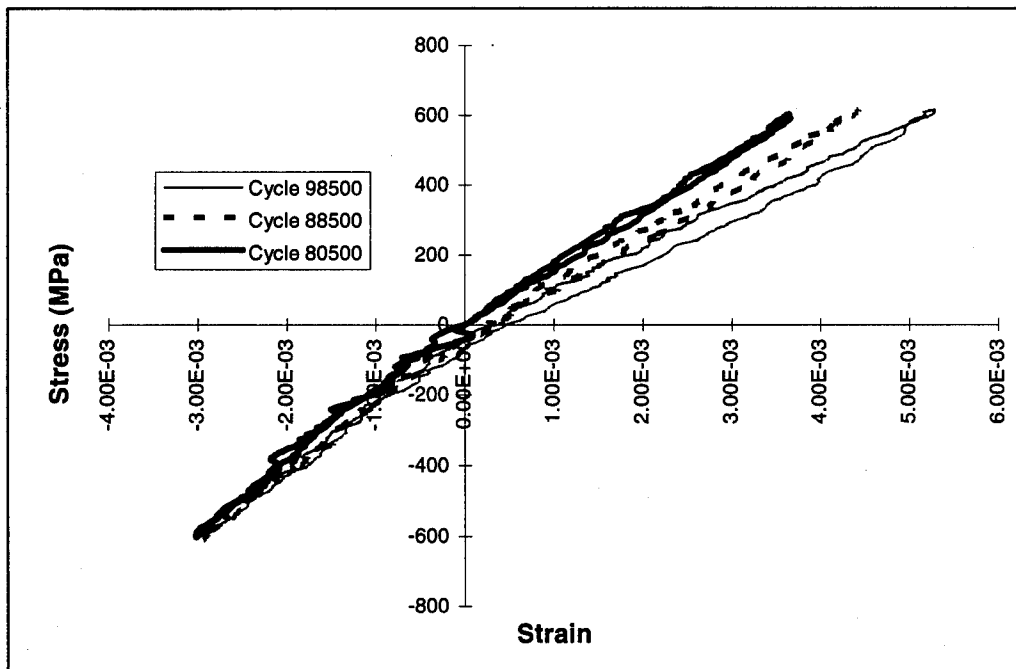
Figure 20. Stress-Strain Response at 625 MPa, T=427 ° C

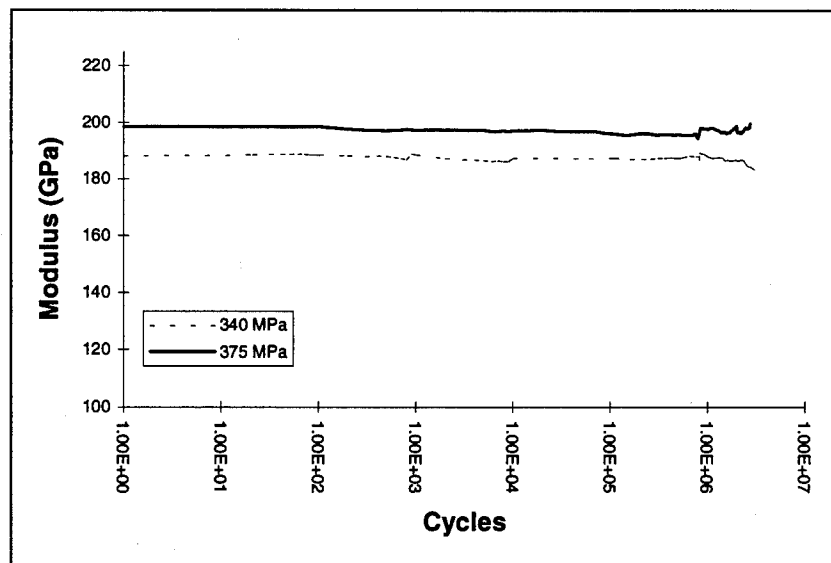
**Figure 21. Modulus vs Fatigue Life for Group 3 Tests**

Figure 21 shows the modulus trends for specimens in Group 3. The modulus remained constant throughout the test showing no indication of damage. Edge replicas showed some fiber cracking after 100,000 cycles and their number did not increase with subsequent cycles, but as mentioned before, this is not indicative of the rest of the specimen. Edge replicas also showed that some matrix cracking developed from the debonding between the fibers and the matrix where the fibers had already cracked. Also, once matrix cracks were detected in edge replicas, they did not increase in number or size. Analysis of the modulus trends indicates that the existing matrix cracks had no effect on the material stiffness and probably did not progress throughout the laminate.

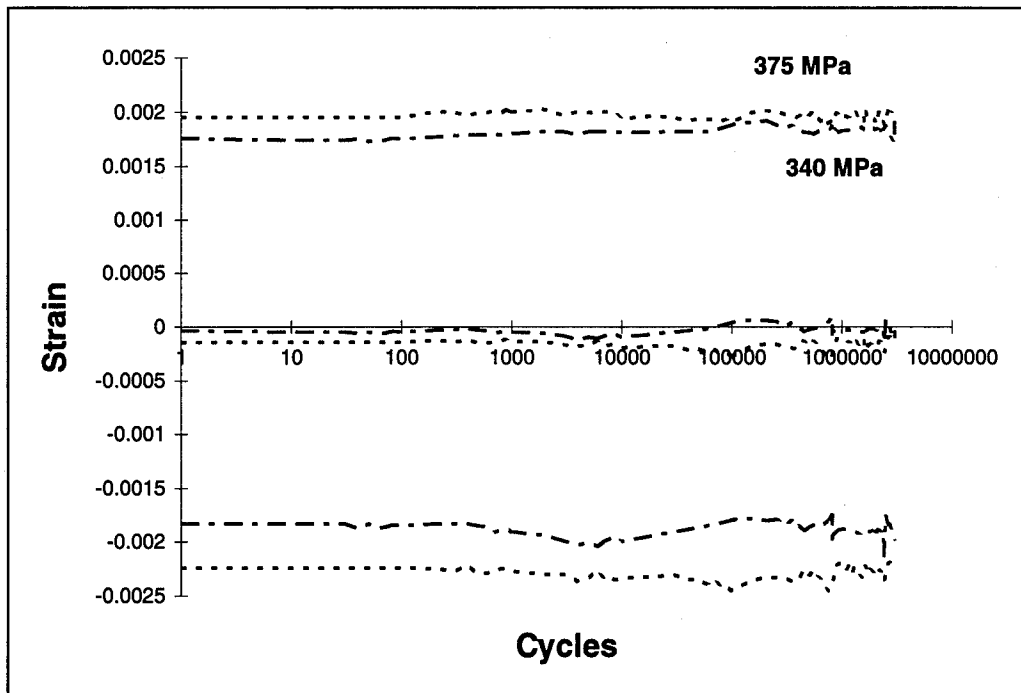
**Figure 22. Group 3 Strain Trends**

Figure 22 shows the strain trends for Group 3. Once again the trends show no evidence of creep. Also, since there was no change in modulus, there is no increase in maximum strain or strain range. Thus, it appears that damage observed in edge replicas has not progressed throughout the composite and that these specimens were cycled below the fatigue limit of the matrix material.

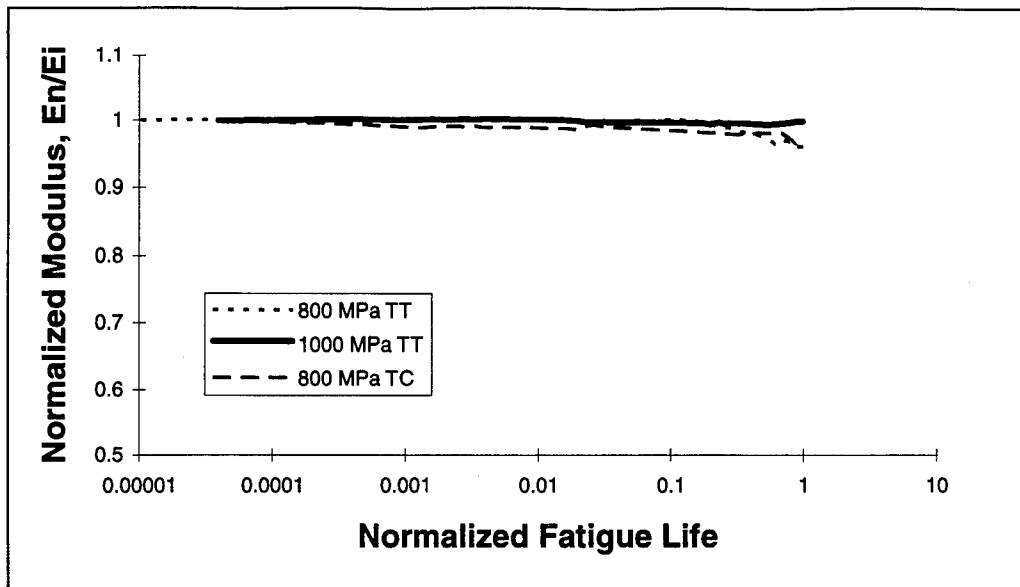
**Figure 23. Normalized Modulus vs Fatigue Life**

Also shown in Figure 23 is the modulus trend for the fully-reversed specimen cycled at 800 MPa. Modulus degradation under tension-tension fatigue occurred over a small number of cycles, spanning only over the end of the fatigue life, while tension-compression fatigue produced damage much earlier in the fatigue life. Once again, the percentage of fatigue life where damage initiates should not be confused with actual cycle number. Strain trends will show that damage initiated at approximately the same cycle count for both loading conditions but progressed at greatly different rates through the composite.

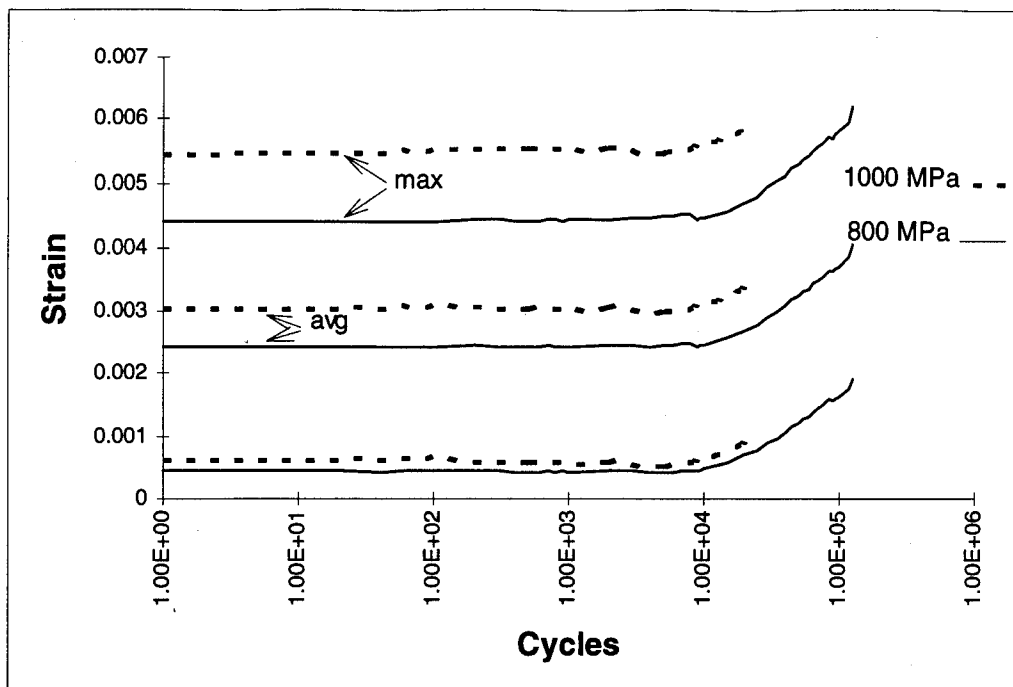
Figure 24. Max, Min and Avg strain, TT HT

The maximum and minimum strain trends are once again important in identifying creep behavior. Figure 24 shows the strain trends for the tension-tension tests conducted in this study. The initiation of damage is seen as a pronounced rise in both maximum and minimum strains at the end of the fatigue life. Unlike the strain trends in tension-compression loading, those for tension-tension loading show evidence of creep behavior. As shown in Figure 25, the maximum and minimum strains begin to rise after approximately 10,000 cycles. To determine whether this increase is a result of damage or creep, the modulus and strain range must be analyzed. Figure 26 shows that the modulus and strain range remain constant for more than 20,000 cycles indicating that the increase in strain between 10,000 and 20,000 cycles is a result of creep and not damage.

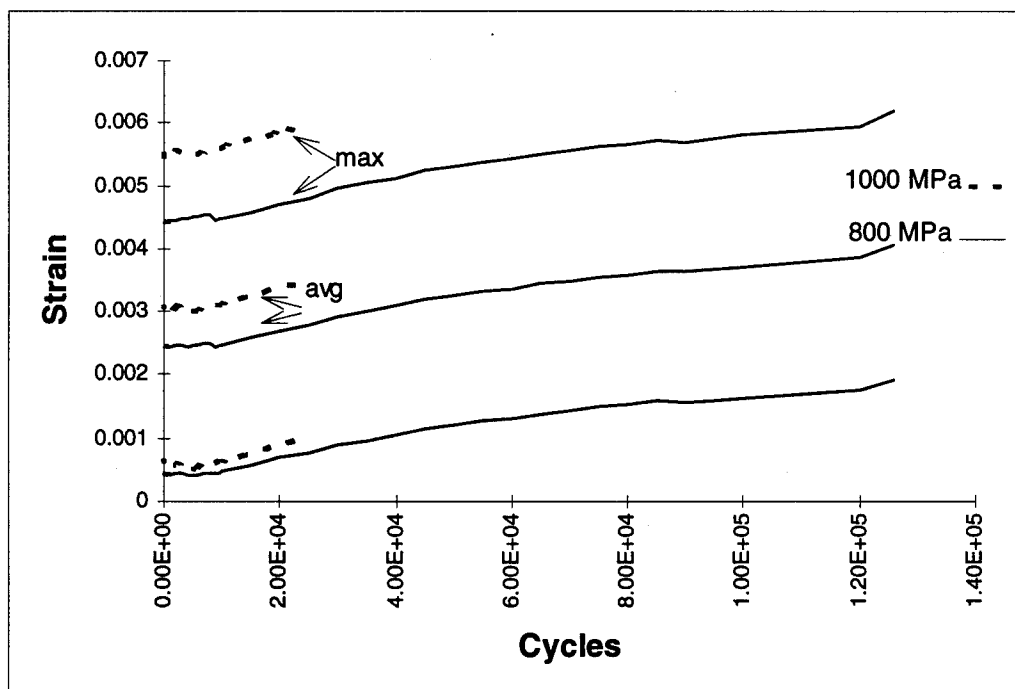
Figure 25. TT HT Strain Trends (Linear Scale)

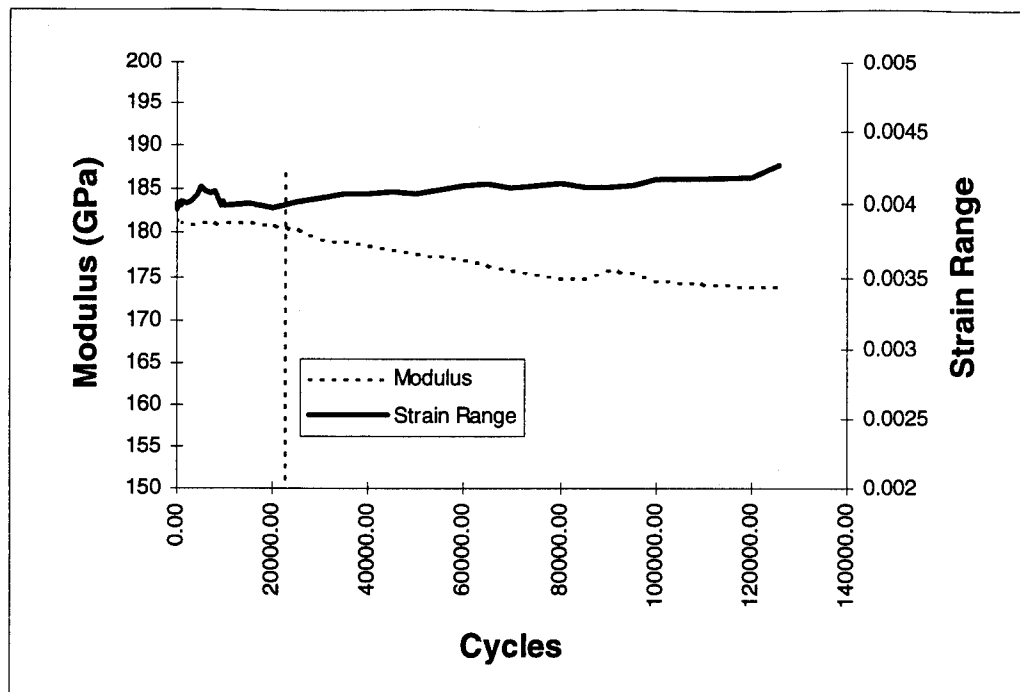
**Figure 26. Modulus and Strain Range, 800 MPa, TT HT**

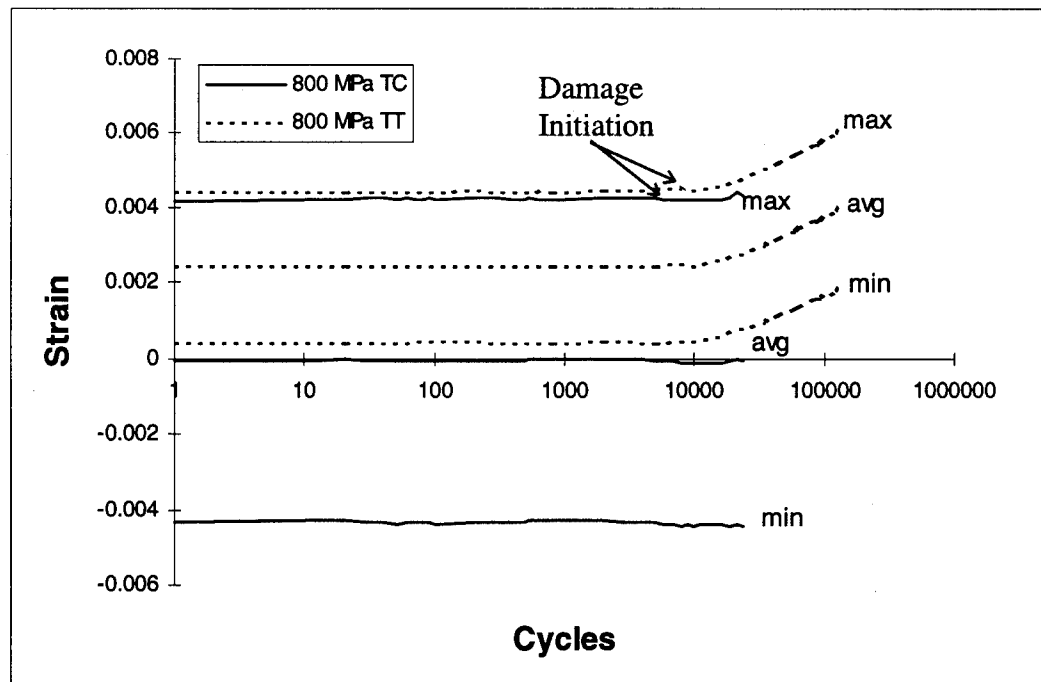
Figure 27. TT vs. TC Strain Trends, 427° C

Figure 27 plots the maximum strains for fatigue tests conducted at 800 MPa in both tension-tension and tension-compression loading conditions. Although damage initiated at approximately the same cycle count, the number of cycles to failure is much greater under tension-tension fatigue. Thus, once damage occurred under tension-compression fatigue, it progressed faster through the composite than under tension-compression fatigue, it progressed faster through the composite than under tension-tension fatigue.

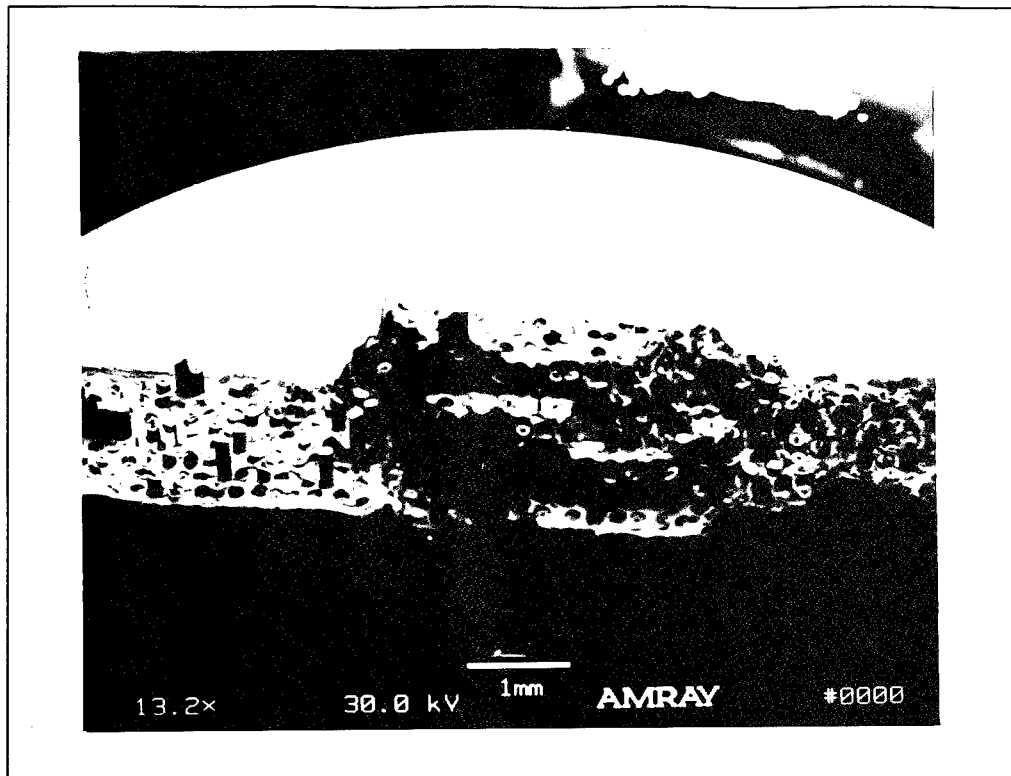
**Figure 28. Fracture Surface at 800 MPa, TC HT**

Figure 31 shows many levels of flat area while Figure 28 shows a single level. This indicates that many cracks were progressing through the composite at low stress. As the stress level increases, one crack tends to dominate resulting in a single level of flat fracture surface area.
